Accident Investigation Final Report

All Engines-out Landing Due to Fuel Exhaustion

Air Transat
Airbus A330-243 marks C-GITS
Lajes, Azores, Portugal
24 August 2001

22 / ACCID / GPIAA / 2001

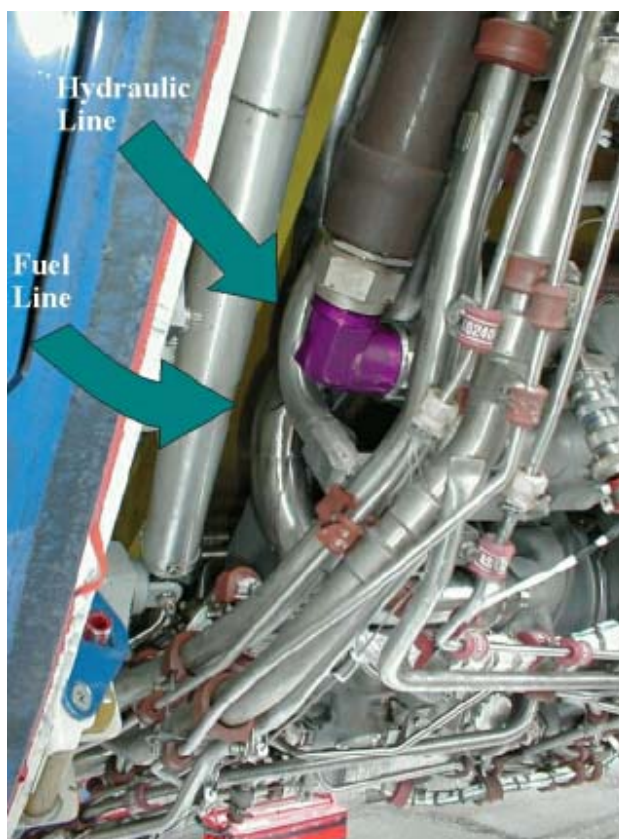
Figure 3 - Right Engine Pipe Contact

The initial inspection of the right engine following the occurrence uncovered the presence of an L-shaped crack on the inlet fuel tube wall (Part No FK30383). The crack was approximately 3.0 inches (80mm) long, and was spread to a width of about 1/8 inches (2.5mm). In addition, the hydraulic outlet tube (pressure) for the rear hydraulic pump was found to be in hard contact with the fuel tube. The cracking on the fuel tube extended to both sides of a mechanically worn (chafed) area where the tubes came into contact. It was evident that the interference and chafing occurred due to the mismatched installation of the post-mod fuel tube (P/N: FK30383) and pre-mod hydraulic tube (P/N: LJ51006). Based on the DFDR data, it was determined that the fuel leak rate through this cracked reached a maximum of about 13.0 metric tons per hour.

Both reports concluded that the fuel and hydraulic tubes fully matched the drawing characteristics for material, form and shape. The fuel tube wall section was measured and showed that the wear had reduced the wall thickness by 0.005 inches, and that the hard contact had resulted in a dent measuring 0.044 inches deep. The examination concluded that the fuel tube fractured in high cycle fatigue at multiple initiation sites in the bore and the outside diameter, due to a combination of vibratory stresses being superimposed on the tube deformation. Also noted were some scratches and deep scores around the chafed location on both tubes. Report MFR 41281 stated that these marks are believed to have been made at the time of installation of the engine because this was the only time the post-SB fuel line and pre-SB hydraulic lines were mounted adjacent to one another. The report con-

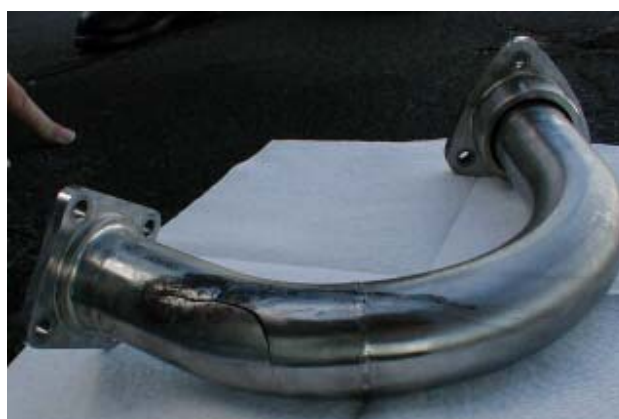
Figure 4 Fuel Pipe Crack & Scratches

cluded that the scratches and scores were directionally aligned and that they could have been caused from repeated contact from a blunt instrument, such as a screwdriver being inserted between the tubes in order to force a clearance between them. There were no cracks initiated from the score or scratch marks.
